ELECTRIC LIGHT POND DAM

NJ 00245

PHASE 1 INSPECTION REPORT NATIONAL DAM SAFETY PROGRAM

FEBRUARY 1980

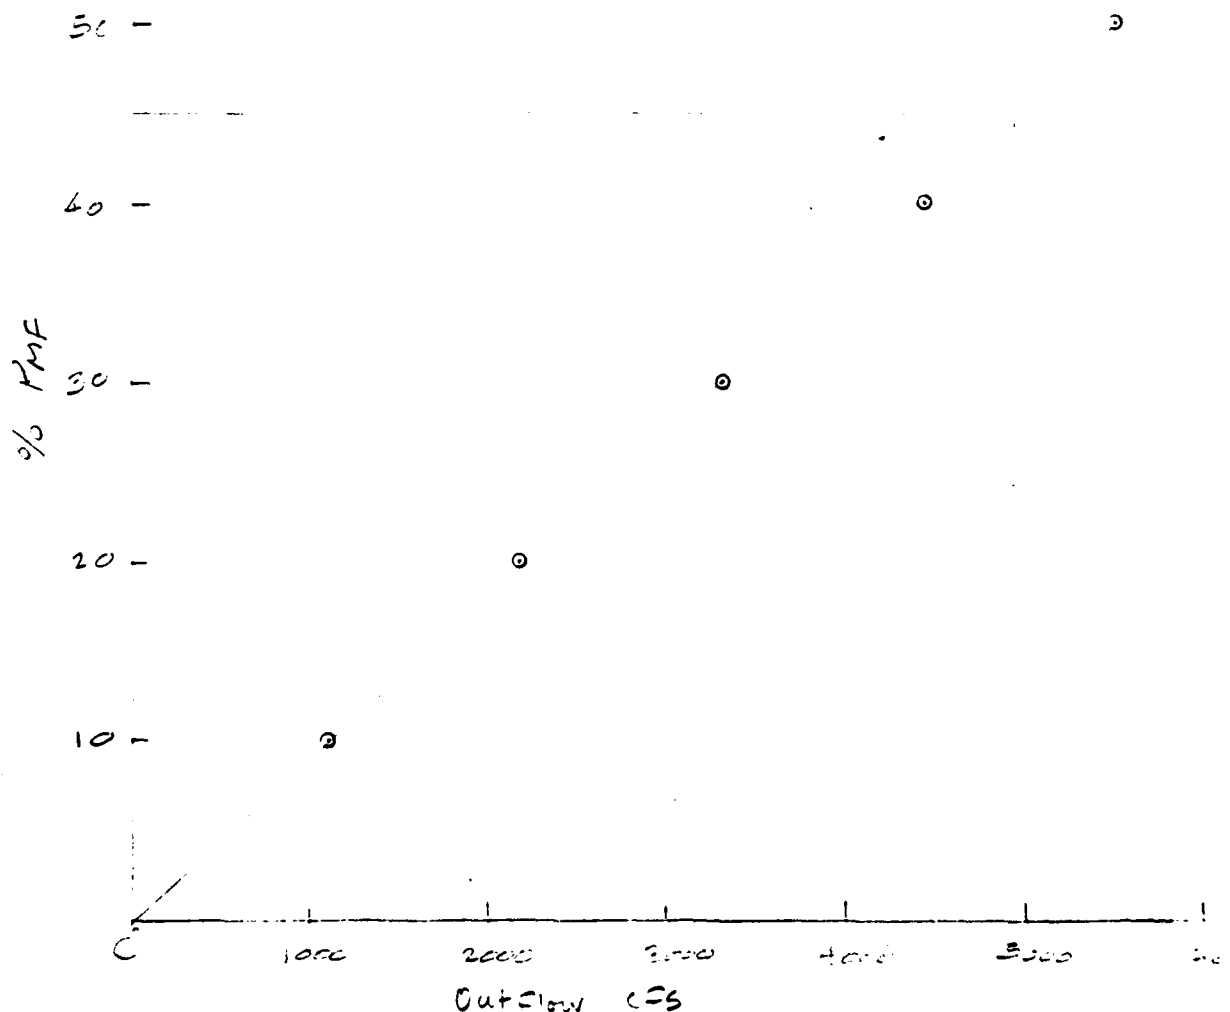
SHEET NO. 7 OF 12
JOB NO. 10-A93-01
DATE 12/7/79

Overtopping of Dam occurs at Ele. 137.6 with
 $Q = 4845$ CFS ($\sim 45\%$ PMF)
